## Confusion due to Contractor Cascading Leads to Major Release of Ammonia During Test of Safety Device

*Published in:*  
Chemical engineering transactions

*Publication date:*  
2019

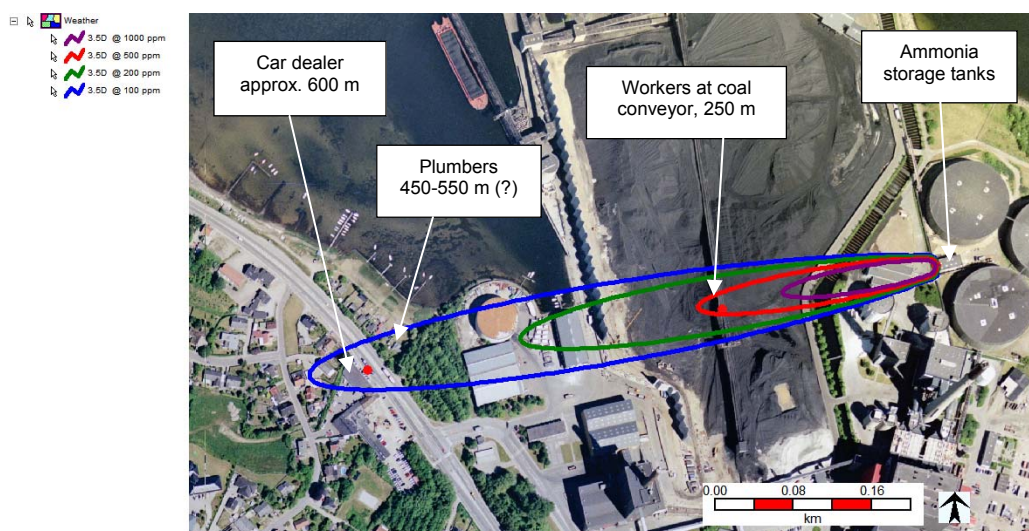
Calculation using PHAST (ver. 8.1) yields a release rate of about 2 kg/s (total release 2.4 t). The weather was fair, wind 3.5 m/s due east and ambient temperature 17 °C. As tanks were under cover, the jet release is assumed to have lost considerable momentum. Pasquill stability class set to D. Dispersion modelling (Figure 2) indicates that the maximum ammonia concentration at the property line (500 m) was about 150 ppm.

Figure 2. Modelling of ammonia vapour dispersion before activation of water curtains and sprinkler systems. Map: © COWI/DDOland 2004
